Theme I

**Case Histories in
Foundations of Structures
and Failure Records**

Failure of the Ghana Law School Building in Accra, Ghana

N. K. Kumapley

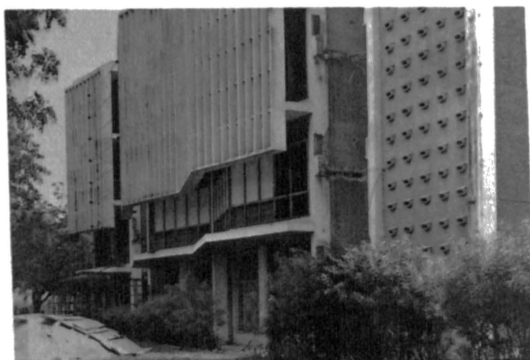
While damage to the two-storey high Lecture Hall was minor, being limited essentially to scattered hair line cracks, the classroom block experienced extensive cracking damage, and considerable distortion within the structural frames. The resulting structural damage was concentrated within the lower two storeys and at the junctions between the stairwells and the adjacent units. Of the three units into which the classroom block was divided, units B and C were the most heavily damaged, and Unit A the least damaged. Fig 1 shows the condition of the damaged structure in the vicinity of the stairwell between units B and C.

Fig. 1 General View of Classroom Block Before Rehabilitation. Note cracks at contact between Unit B and Stairwell.

- (i) the partial underpinning of the structure to facilitate the extension of the affected footings to a total depth of about 4m to ensure that they are placed on the clay shale rather than on the channel deposits. All the columns, mainly of units B and C, falling within the inferred limits of the buried channel were underpinned. This aspect of the work was carried out with the usual precautions of monitoring movements in the superstructure, especially the installation of tell-tales across major cracks to indicate sudden movements (Fig. 6). Except for the excavations for footings close to the soakaway in which major groundwater seepage was noted, most of the excavation was carried out under conditions of minimal groundwater seepage, although the excavated material was in a moist state.

- (ii) a complete re-design of the two stairwells to separate them from the adjacent units and to place them on new footings, also carried through the channel deposits on to the clay shale.
- (iii) general repair and improvement of the surface drainage provisions.

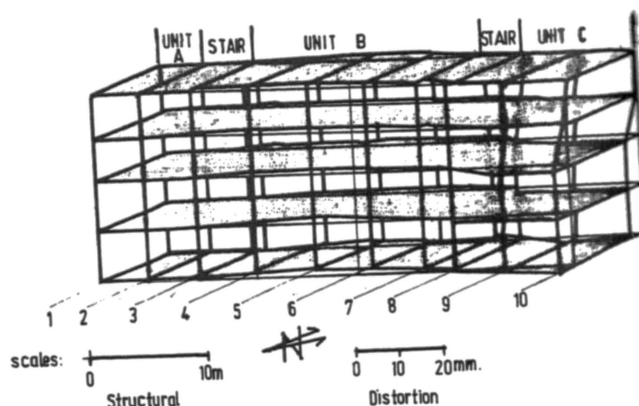
In the absence of information on the original floor levels and the locations and elevations of original construction bench marks, it was impossible to determine absolute magnitudes of vertical movements. However, based on the assumption that the finished floors were originally level, precise levelling was employed to establish that the central part of the classroom block had heaved by about 80mm with respect to the edges. Furthermore, tilt measurements, made by lining up the columns with a theodolite, showed that the structural frames had undergone maximum angular distortions ranging from 1/280 in Unit C to 1/720 in Unit B. The general distortion pattern of the whole structure is shown in Fig. 2. It is interesting to note that the threshold angular distortion for cracking damage to framed structures has been estimated at 1/500 by both Burland et al (1975) and Skempton et al (1956).

Fig. 2 General Distortion Pattern of Structure.

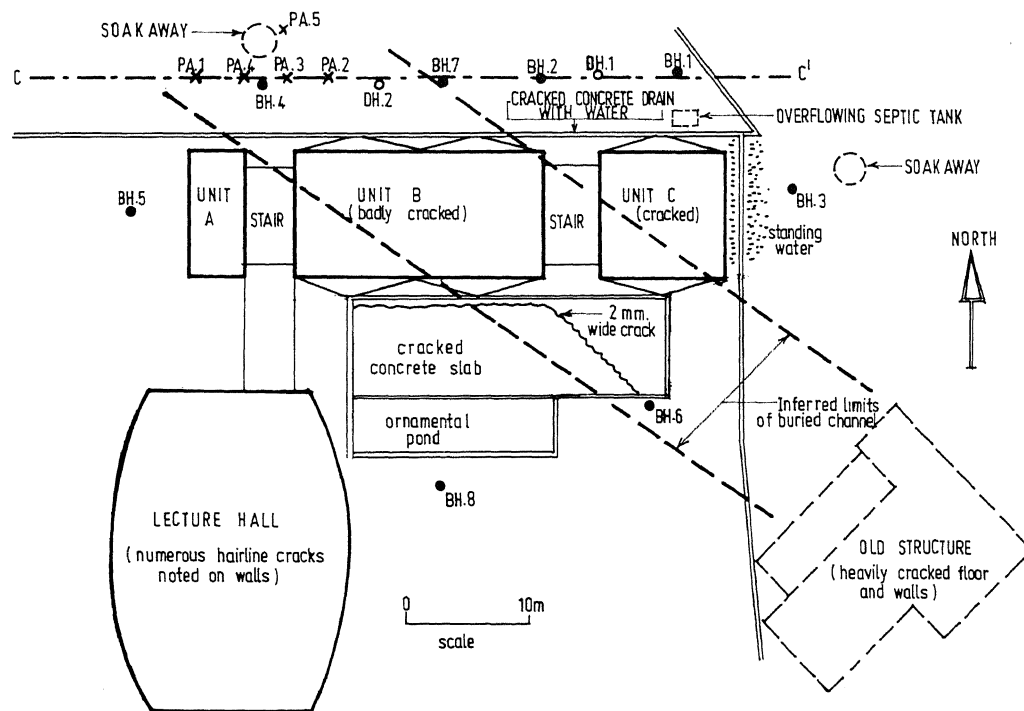
At the time of the investigations, the surface drainage facilities were generally in a poor state of repair, as shown in Fig. 3. The concrete storm drain running along the north side of the classroom building was cracked in many places, thus permitting ingress of water into the foundation soil. There was also some evidence that considerable leakage was occurring from the ornamental pond in front of the classroom block. General ponding of sections of the site was noticed, even though the investigations were carried out during the dry season. The Accra area experiences two rainy seasons in a year, the main season reaching its peak in May-June and the minor one in October. The driest period of the year is from January to April, when the soils attain their most desiccated state.

Fig. 3 Details of Fieldwork

The investigation have established the cause of structural distress as differential foundation heaving due to saturation of the "channel deposits", access to water

being caused by poorly maintained surface drainage facilities and the inadvertent siting of one of the main soakaways within the buried "channel" (Fig. 3). A test hole (PA 5) located near this soakaway showed that the surrounding soil was waterlogged from a depth of 2m, when the general groundwater table in the area was at a depth of about 5m.

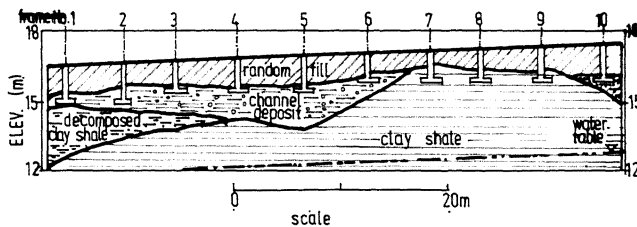
A detailed programme of geotechnical investigations, consisting of geophysical surveys and the drilling of a total of 16 borings using the power auger, percussion and rotary drilling down to a depth of 25m, failed to reveal any abrupt changes within the subsurface profile to indicate any evidence of major faulting at the site. The locations of the various borings are shown in Fig. 4 while a typical sub-soil profile along section C-C' shows that the foundations of the classroom block were placed on three types of material, namely the fresh and the decomposed clay shale and the so-called "channel deposit" consisting of a highly permeable formation of gravels in an expansive clay matrix, up to 2m thick, which appears to have been laid down in a buried channel sometime past.

Fig. 4 Typical Sub-Surface Profile

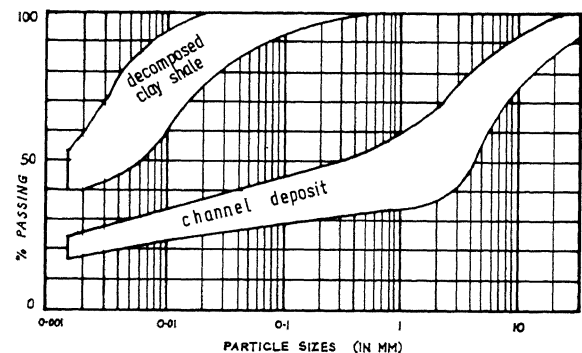
Both the "channel deposit" and the decomposed clay shale have typical liquid limits and plasticity indices of 60% and 35% respectively. The relatively wide difference in the particle size distributions of the two soil types is, clearly shown in Fig. 5.

Fig. 5 Particle Size Distribution Ranges for Decomposed Clay Shale and "Channel Deposit".

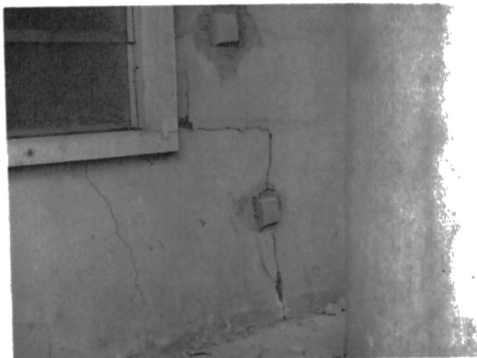
Fig. 6 Typical Arrangement for Monitoring Crack Movement During Underpinning
